# Caravan Mover Fault Flowchart V1.3

Written for Carver AR2-1 and Truma M1

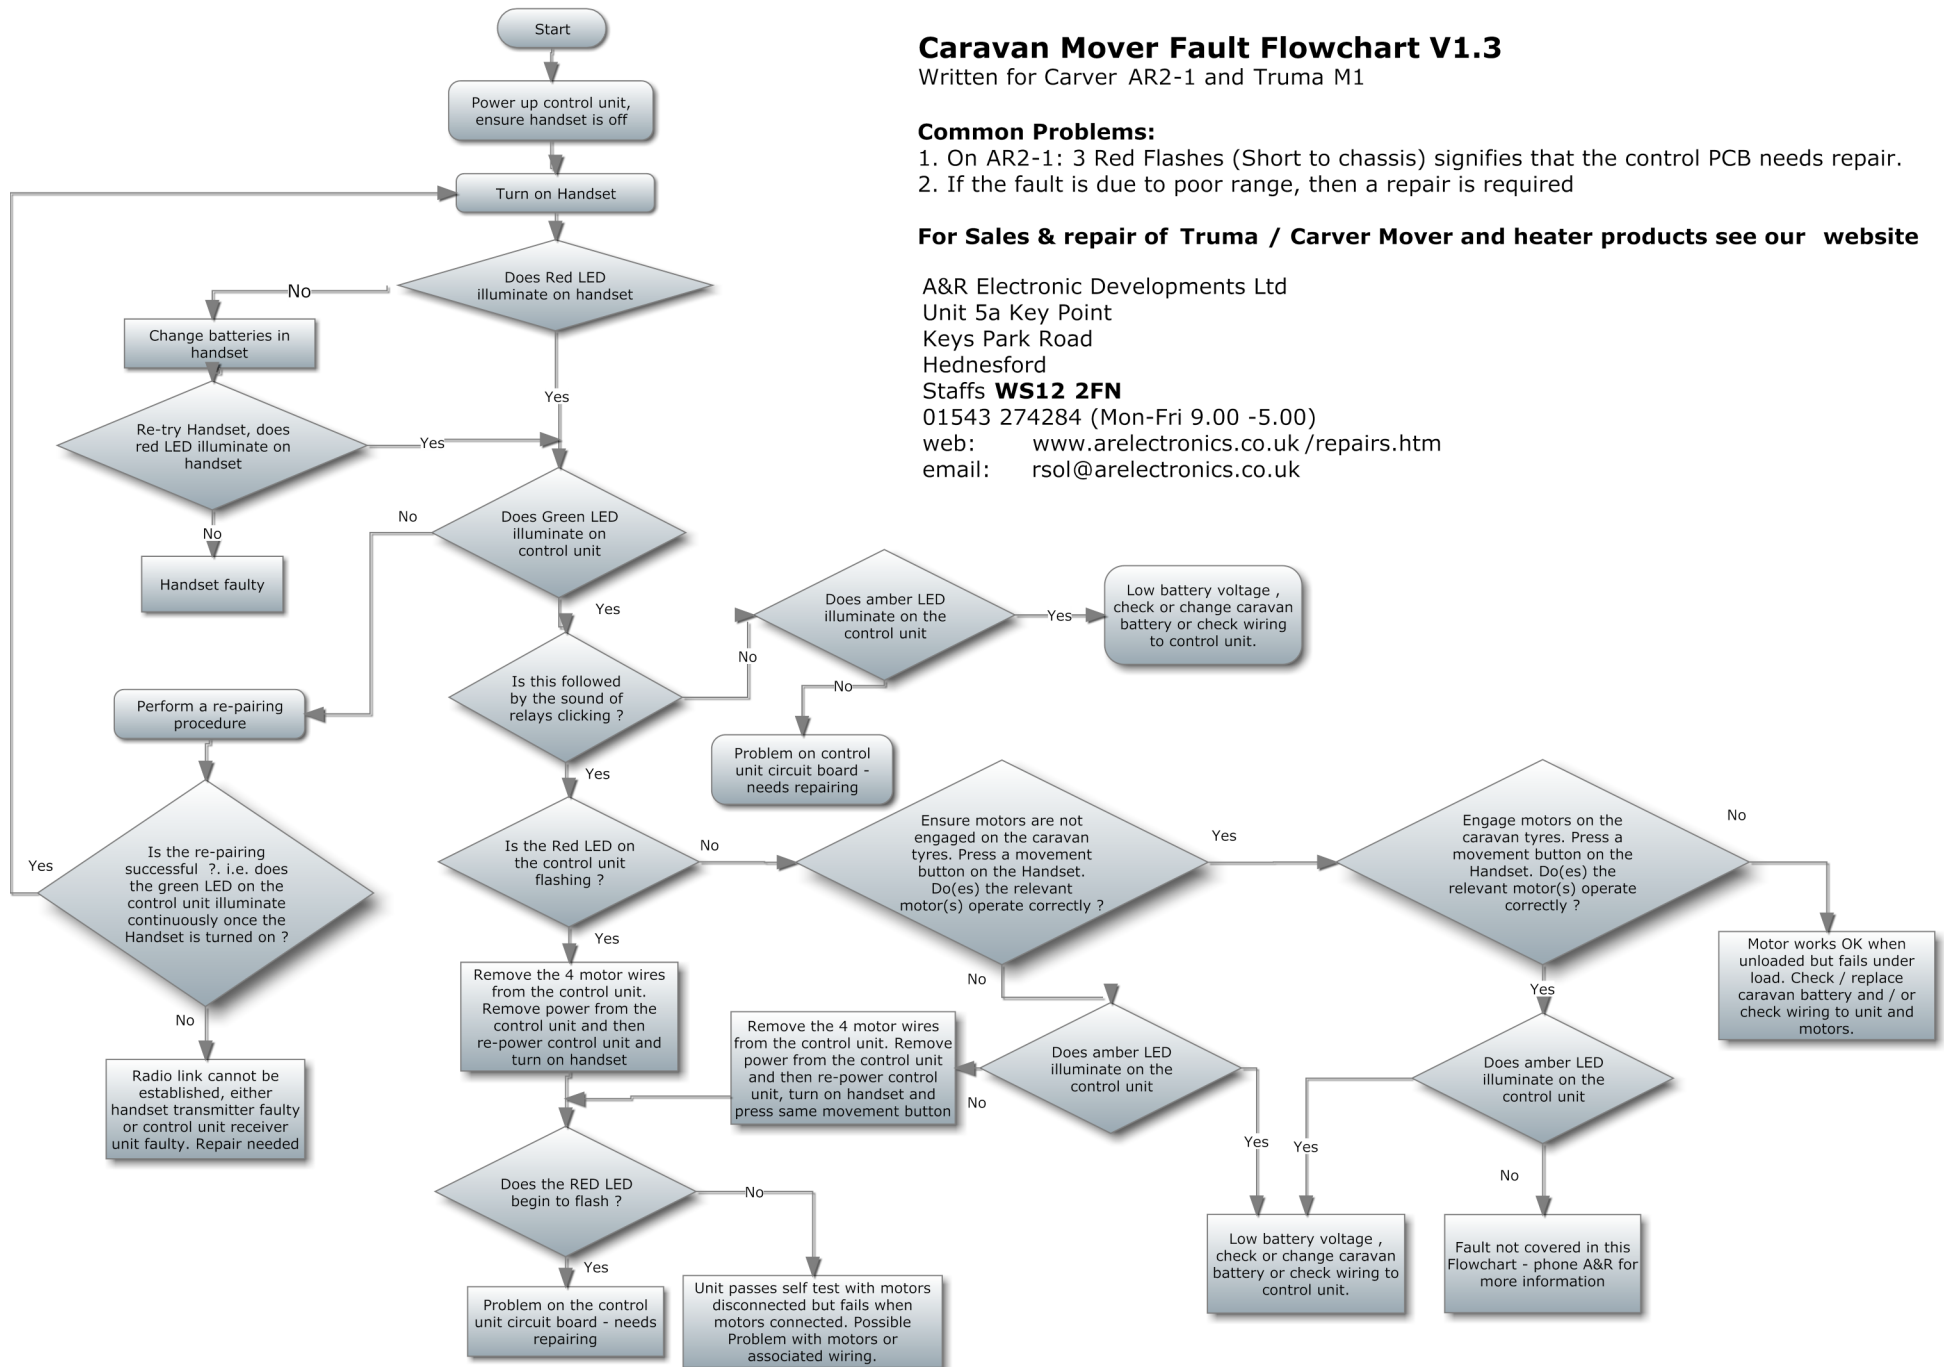
1. On AR2-1: 3 Red Flashes (Short to chassis) signifies that the control PCB needs repair.
2. If the fault is due to poor range, then a repair is required
