Caravan Mover Fault Flowchart V1.4

Written for Carver AR2-1 and Truma M1

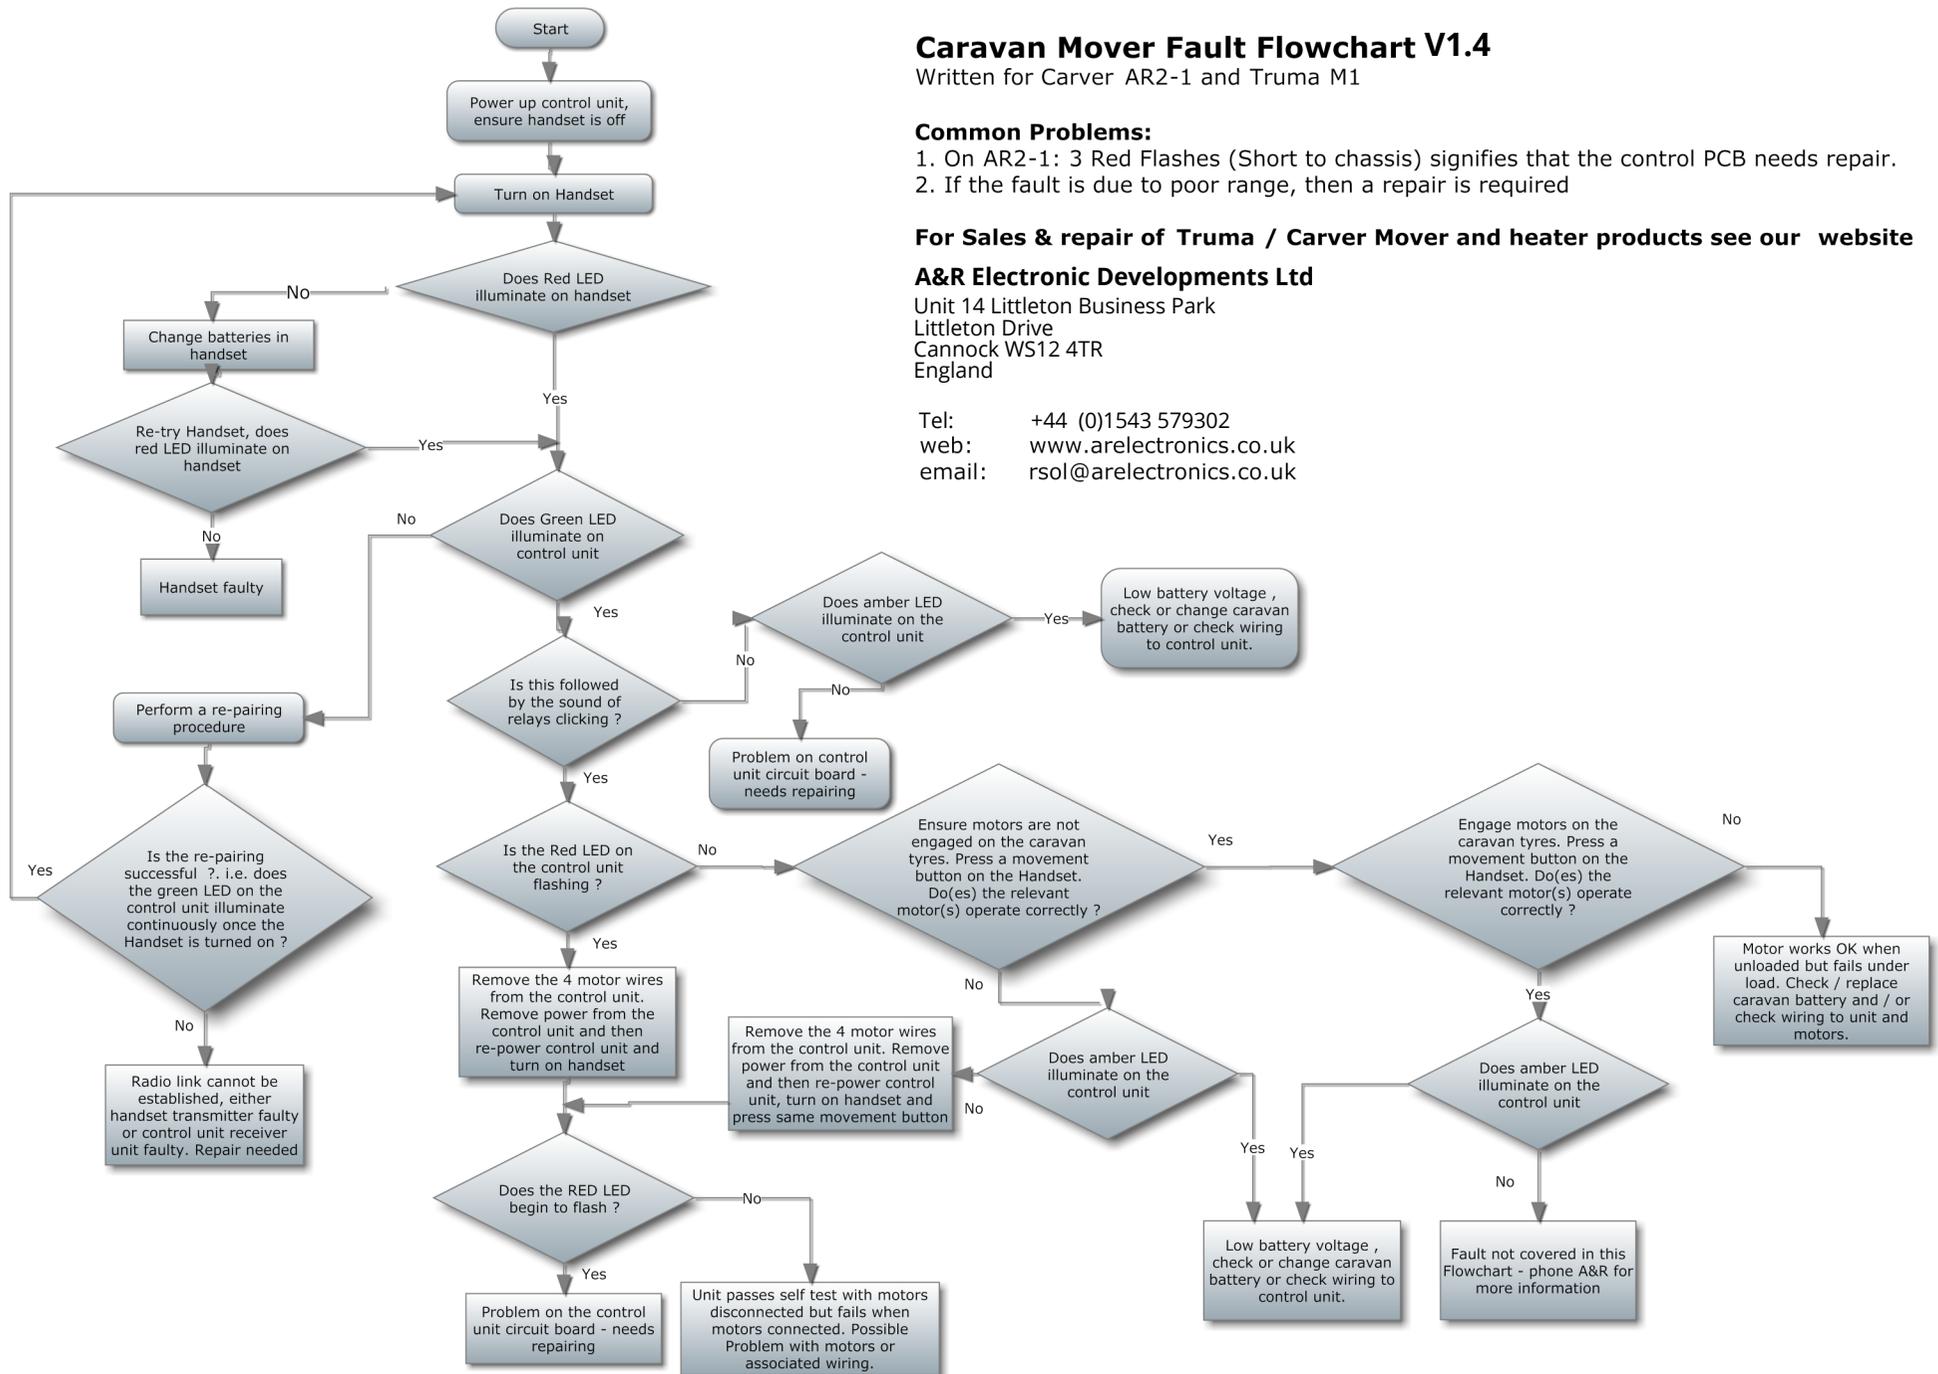
Common Problems:

1. On AR2-1: 3 Red Flashes (Short to chassis) signifies that the control PCB needs repair.
2. If the fault is due to poor range, then a repair is required
